Project Profile - Construction Quality Control

Roof Replacement Project: Clark County School District
Benchmark On-site Roof Consultant: Martin Smith
Roof System Type: Mechanically attached, 60-mil single-ply PVC (Johns Manville)
Roof Project Size: 52,312 square feet
Project Duration: January - June, 2008

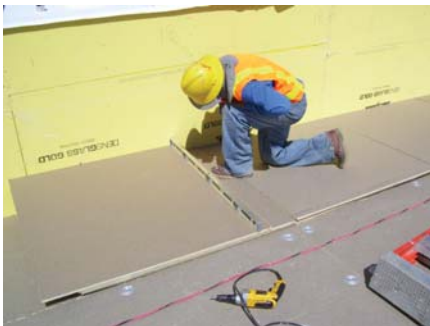
Rofer checking tapered board for insulation slope.

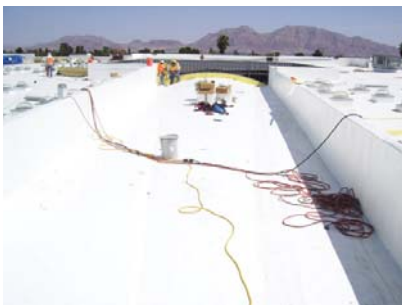
Overview of roof membrane installed.
