# Condensation: Refrigerated Processing and Cold Storage Operations

**By: Jennifer Stephan, RRC, CDT, ICC Building Inspector; and John Sutton**  
Building Envelope Consultants

*Why condensation, not conventional roof leaks, is the leading cause of enclosure failures in refrigerated processing and cold storage facilities, and how the right air-seal strategy prevents it.*

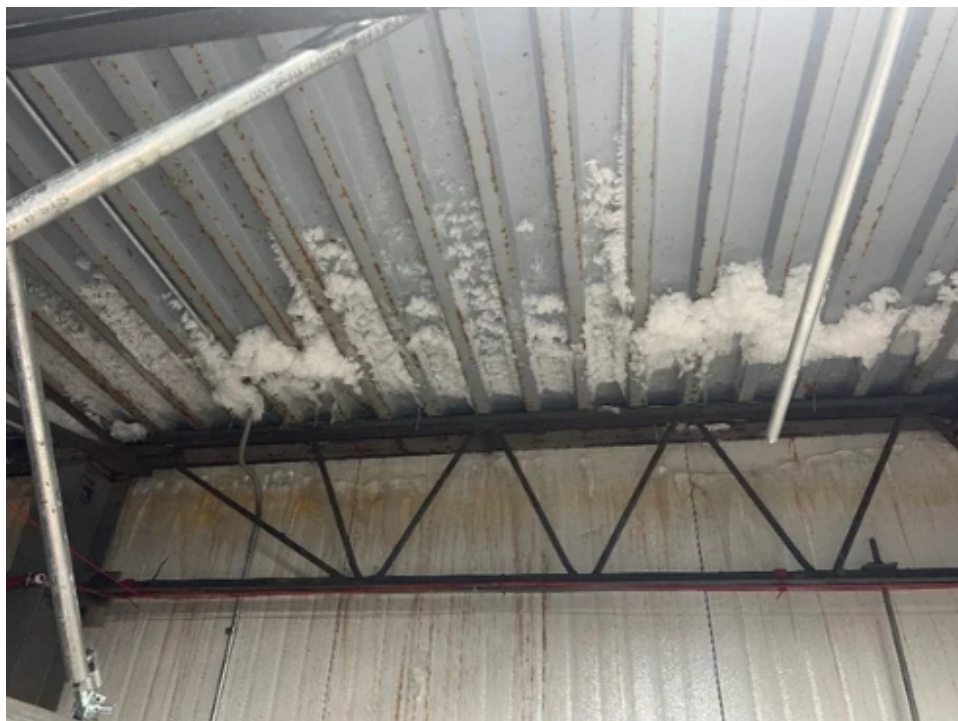
*Ice accumulation at a roof-deck-to-wall transition — a signature of condensation caused by air infiltration.*

- **Infiltration.** Warm, moist air is drawn through unsealed roof-to-wall transitions, penetrations, and doorways, mixing with cold interior air and condensing on steel surfaces. Refrigeration-driven negative pressure and downward cold-air movement intensify the pull. Infiltration is the most common cause of reported system failures.

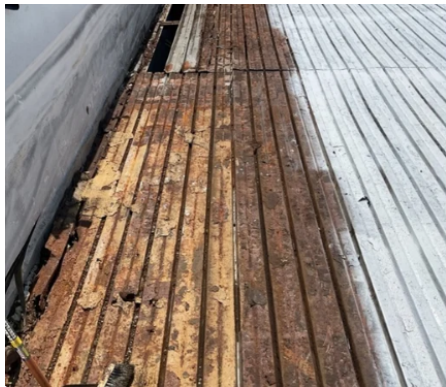
*Steel roof decking corroded through by prolonged, unmanaged condensation exposure.*

Infiltration isn't limited to poorly sealed transitions. Mass infiltration occurs every time a door between a cooled space and a semi-cooled or unconditioned space opens for forklift or pedestrian traffic. Even brief, automated door cycles introduce enough warm air to drive corrosion on the steel deck and framing nearby.

Unchecked infiltration doesn't stay a surface-level nuisance. Cyclical condensation, repeated every time outside air is warmer than the refrigerated interior, corrodes steel decking over time. Left unaddressed, that corrosion progresses to structural failure of the decking itself, and in severe cases, to a roof blow-off.

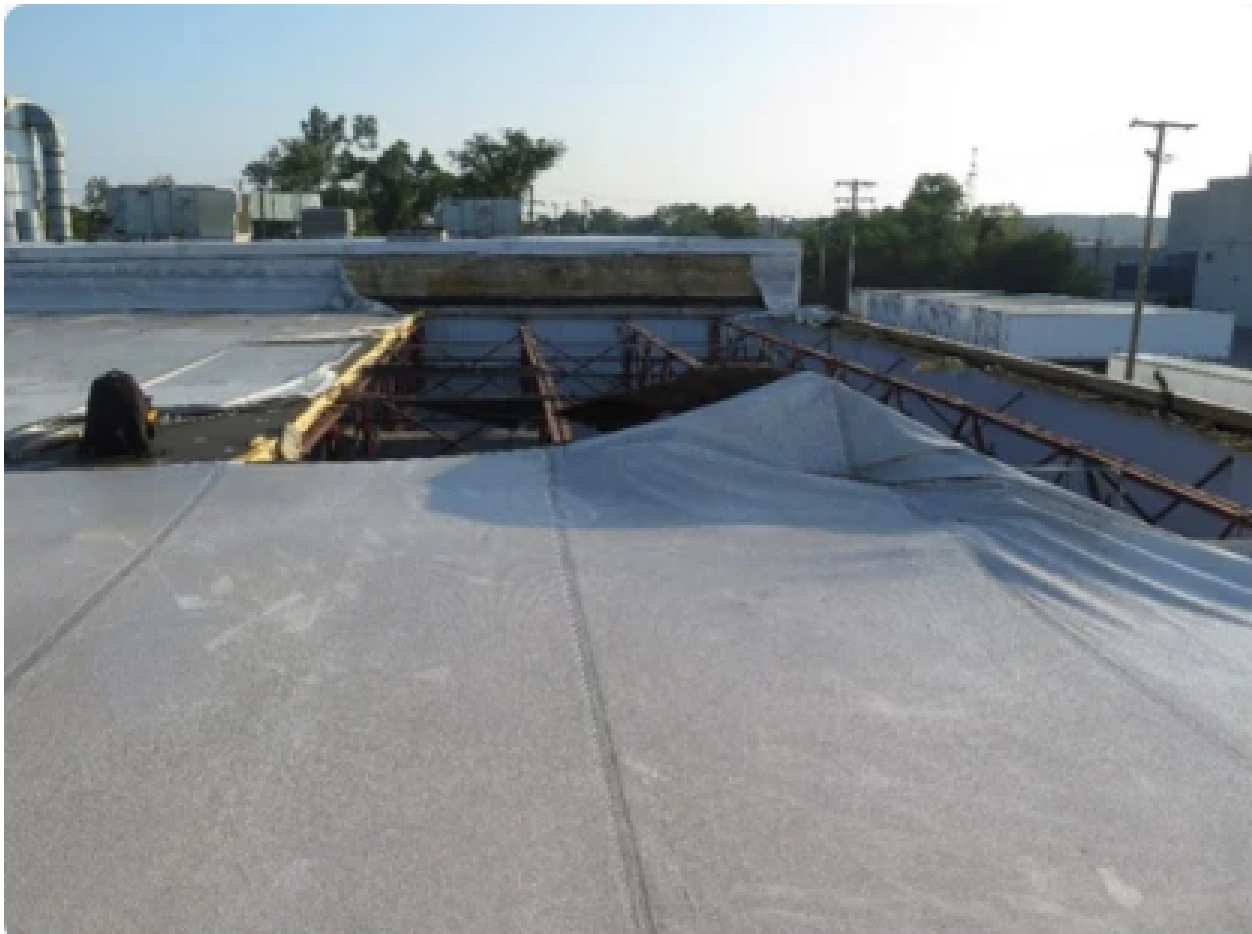
*Roof blow-off caused by severe deterioration of steel decking along a brick parapet wall — the end state of unmanaged, cyclical condensation.*
