WHY IS MY METAL ROOF LEAKING?

Proper Repairs and Consequences of Improper Repairs

Ray Heisey, PE, RRC

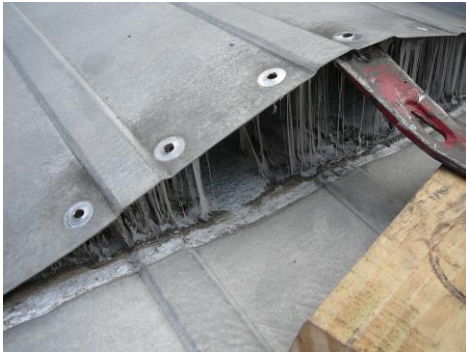
BUTYL SEALANT WEBBING BETWEEN ROOF PANELS.

To properly seal a joint between two metal sheets, the sealant must be fully-adhered to both metal surfaces being joined. If the joint is pulled apart, the sealant should 'web' looking like a spider web as it stretches between the two sheets of steel. Properly installed butyl rubber sealant forms a gasket between the steel surfaces being joined together and repels the entry of water and air into the joint. Metal roof manufacturers also supply polyurethane sealants for use in sealing metal roofs, primarily at exterior gutters and roof penetrations. Polyurethane sealants form a skin and can be exposed to ultraviolet light without detrimental effect.

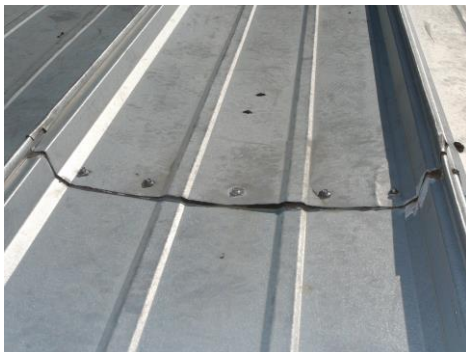
GAP BETWEEN ROOF PANELS AT END LAP.

So, you have a leak in your metal roof. If the solid steel roof sheets cannot leak, where do you investigate to find the cause of the leak? Start with sheet metal lap joints where two or more sheets are joined together. This would include roof panel end laps, side laps, perimeter flashings, and roof penetration flashings. Look for poor fit-up of the steel sheets, which produce gaps and voids that are difficult to seal. A small wire probe inserted into a joint between two sheets of metal can help determine whether sealant is present, the type of sealant, and whether sealant is contiguous in the sheet metal joint.

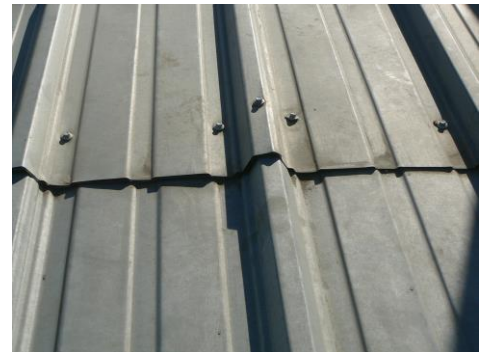
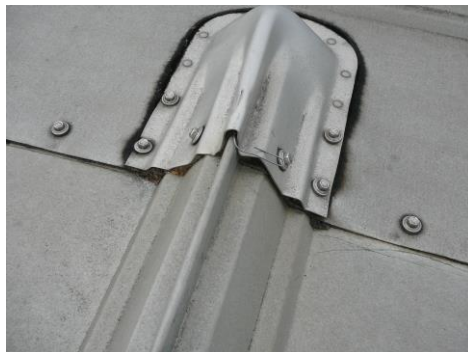
WIRE PROBE USAGE TO CHECK FOR SEALANT.

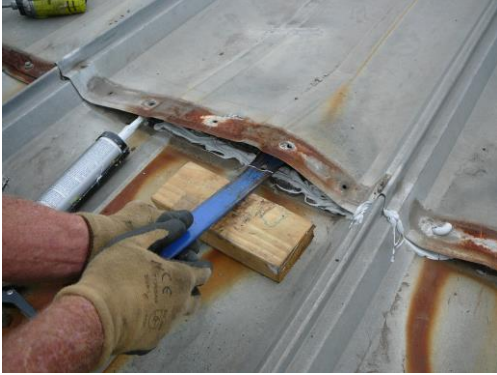
RESEALING END LAP WITH POLYURETHANE SEALANT.

be fully removed from the surface of the steel sheets. A moisture curing, pumpable polyurethane sealant is an excellent replacement sealant. A polyurethane sealant is compatible with butyl rubber sealants and will tenaciously bond to even imperfect surfaces.

The correct repair for an improperly sealed sheet metal joint is to remove the fasteners, open the joint, remove any dirt or failed sealant, reseal the joint with new sealant, and install new fasteners. Since the joint may not be able to be fully opened, such as with a standing seam metal roof, there is not enough room to install butyl tape sealant as was originally used. The sheet metal joint may have moisture and dirt present from water infiltration. The old butyl sealant may not be able to

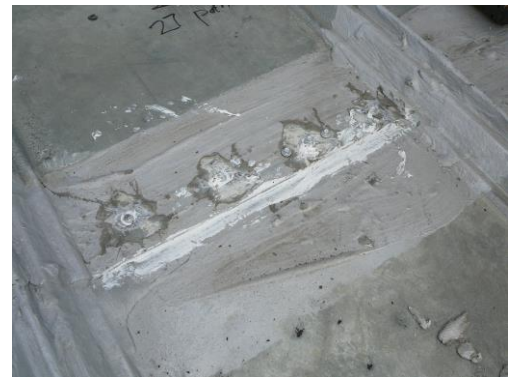
RESEALED ROOF PANEL END LAP JOINT.

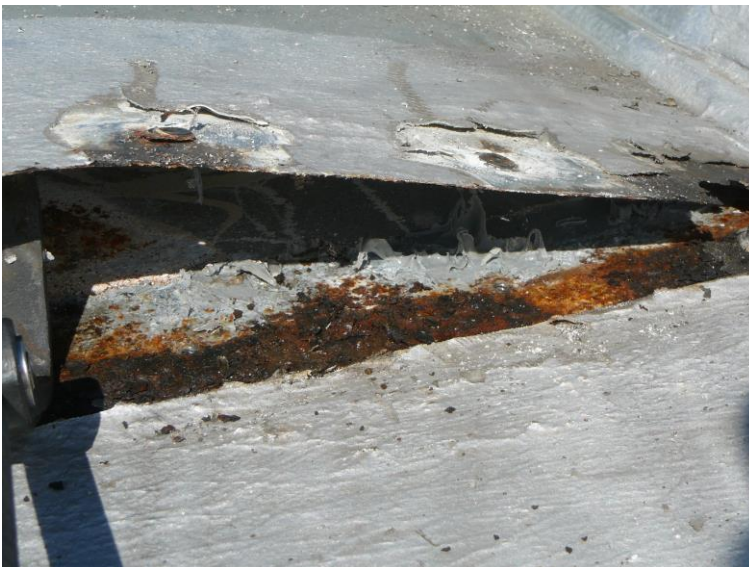
Applying a topical repair material can trap existing moisture in the joint between the steel sheets or if the material is not properly adhered, allow outside moisture to be trapped under the repair

TRAPPED MOISTURE CAUSED ACCELERATED CORROSION.

Improper repairs are frequently attempted on metal roofs through the use of coatings, caulking, sealant, and single-ply membranes. In most cases, these repairs are topically applied and do not address the root cause of an improperly installed or failed sealant joint. Topical repairs rely on the adhesion of the coating, caulking, sealant, or membrane to the surface of the steel around the roof panel lap joint. Any previously applied repair materials must be fully removed and cleaned from the steel around the lap joint as recommended by the coating, caulking, sealant, or membrane manufacturer. Failure of the topical repair material to completely adhere to the steel roof panel surfaces could lead to moisture being trapped under the topical repair.

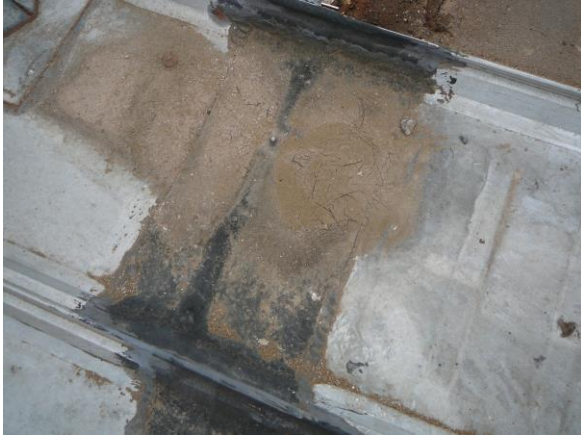
EPDM MEMBRANE REPAIR OVER A ROOF PANEL END LAP.

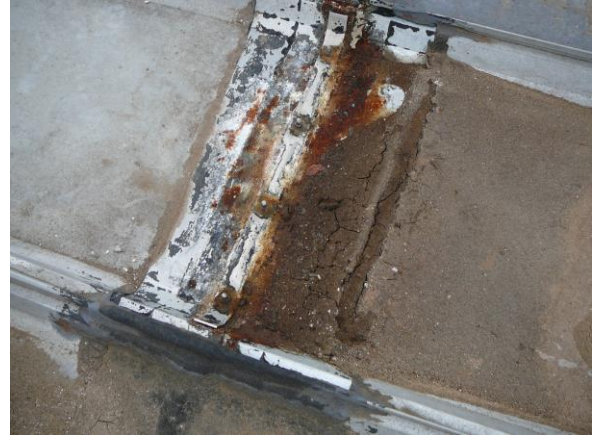
REMOVED EPDM MEMBRANE REVEALS SEVERE CORROSION.

material. In any case, moisture trapped on top of or between the steel sheets will lead to deterioration and require replacement of the corroded components. In severe cases, the underlying structural members can also corrode, leading to extensive repairs or replacement.

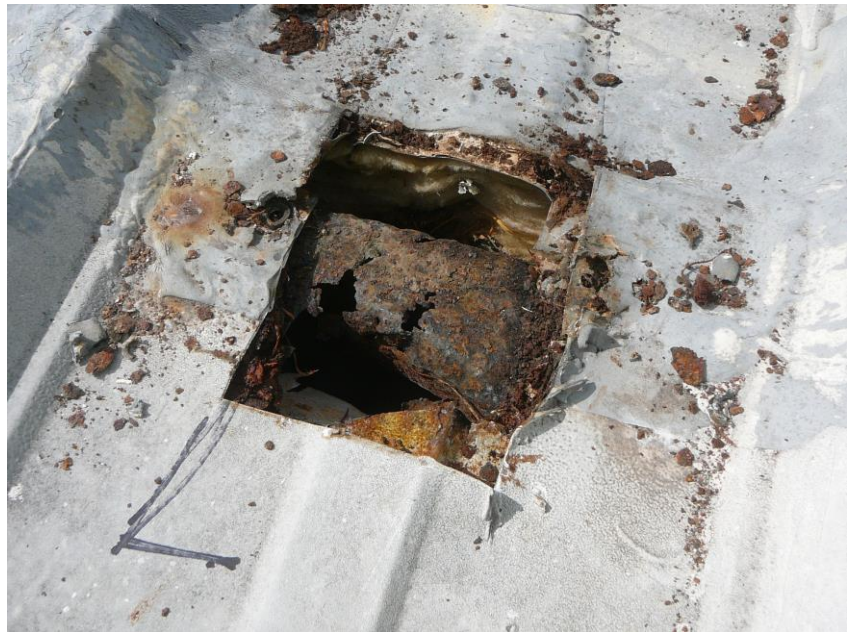
SEVERLY CORRODED ROOF PURLIN UNDER RUSTED ROOF PANEL.
